**Site Name: Tŷ Cambria, 29 Newport Road, Roath, Cardiff, CF24 0TP**

**Report Reference: WWE25161 PRA – Preliminary Roost Assessment**

Date: 02/10/2025

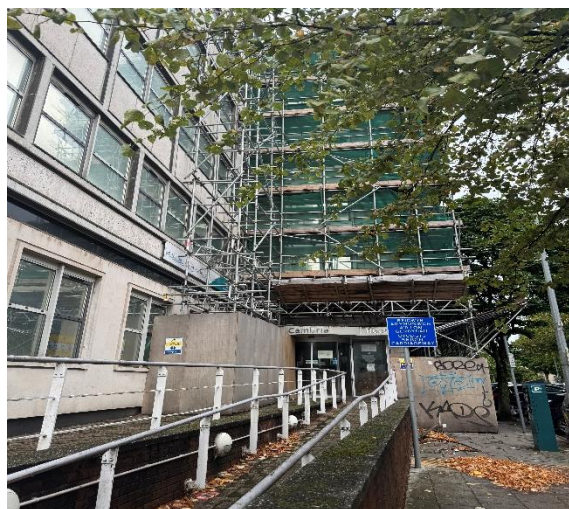
A visual inspection of the exterior of the building was limited due to the height of the building. Scaffolding had already been erected onto the eastern front that was inaccessible during the current survey, also restricting external inspection of this section of the building. However, as these areas are of the same age and construction as the rest of the building – which was found to offer negligible suitability for roosting bats – this limitation is not considered a serious constraint.

**Figure 3 – Scaffolding present on eastern side.**

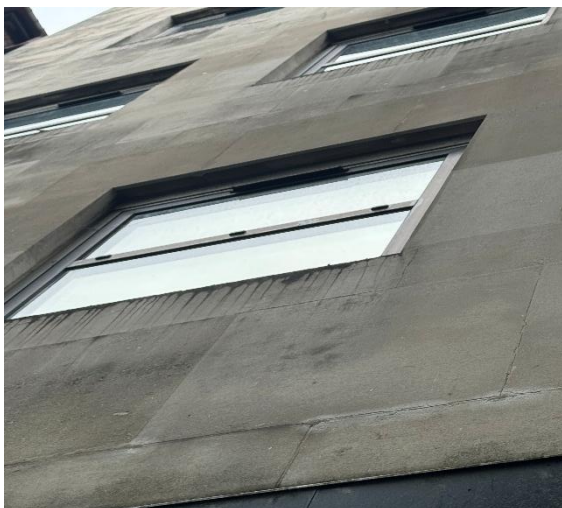
The structure is a multi-storey building formerly used as offices. The exterior is comprised of concrete panels. No cracks within concrete panels were identified and mortar was in good condition. There are numerous windows on each floor and elevation, these sit in metal frames, which are flush to the external walls. Netted scaffolding was present on the eastern side of the building during the survey, limiting access to and inspection of this section. The netting may also prevent and restrict bats from entering or leaving any roosting features, if present. That said, as noted in the constraints section, this area is of the same age and construction as the rest of the building, which offers negligible roosting suitability, so this limitation is not considered significant.

**Figure 4 – Example of exterior walls and windows.**

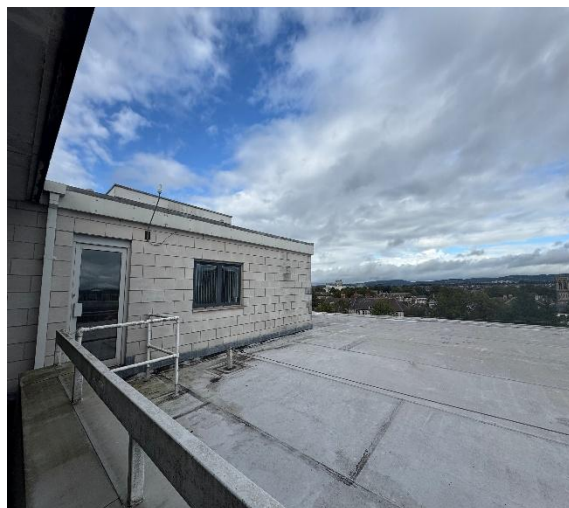
No evidence of nesting birds was identified on site, though feeding remains, likely left by gulls were present. The structure does have suitability to support nesting gulls on its roof.

**Figure 5 – View of roof.**

Site works should commence outside of the bird nesting season, or, if work has to be carried out during the nesting season (generally from 1<sup>st</sup> March until 31<sup>st</sup> August, although birds are known to nest outside of these dates in suitable conditions), a nesting bird check will be required and must be carried out by a suitably qualified ecologist just prior to works commencement. Any active nests should be protected by a suitable buffer, as instructed by the ecologist, until the young have fledged, as confirmed by the ecologist.

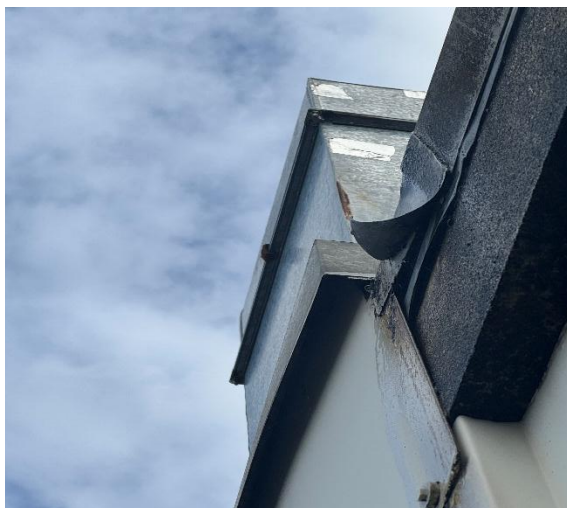
The roofs were flat comprised of bitumen felt. The roof of the structure at the top of the building had raised lead flashing creating a suitable roosting location for bats.

| Suitability for bats | Potential roost features and evidence of use identified |
|---|---|
| Low | <p>The following potential roosting feature was identified on the structure:</p> <p>Feature 1: raised lead flashing on the roof at the top of the structure.</p> <p>This feature is considered sub-optimal as is unlikely to offer thermal stability to roosting bats.</p> <p>The structure is considered to be of low suitability for roosting bats as the potential roosting feature identified is only considered suitable to be used by individual bats opportunistically. However, is not considered suitable to support bats on a regular basis or a roost of high conservation concern.</p> |

**Figure 6 – Example of raised lead flashing.**

Due to the sub-optimal suitability of Feature 1 to support bats, a pre-works inspection by a suitably qualified ecologist with an endoscope is required to determine bat presence/absence prior to removal. Ideally, the pre-works inspection would be undertaken within the bat active season between May- September.

Features (e.g. lead flashing, roofing) should also be soft-stripped by hand and checked for bats prior to demolition.

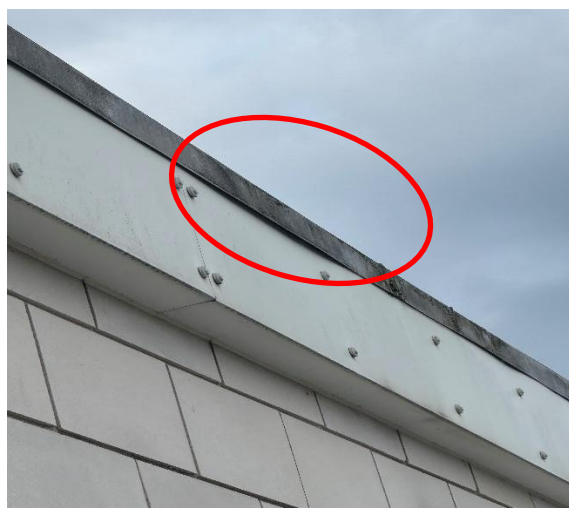
**Figure 7 – Example of raised lead flashing.**

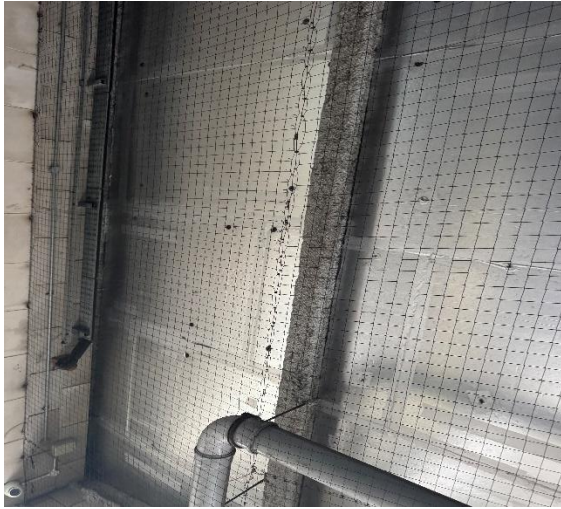
A ground level car park is present to the north east of the structure. This is open to the elements – the lower section walls are comprised of brick and mortar, and the top section is barred metal fencing. A large metal shutter door is present on the northern elevation of the building. The walls and ceilings of the car park are well sealed with no features present to support roosting bats. Netting covers the ceiling of the car park to prevent birds from nesting.

**Figure 8 – Example of netting within car park.**
