**Site Name: Tŷ Cambria, 29 Newport Road, Roath, Cardiff, CF24 0TP**

**Report Reference: WWE25161 PRA – Preliminary Roost Assessment**

Date: 02/10/2025

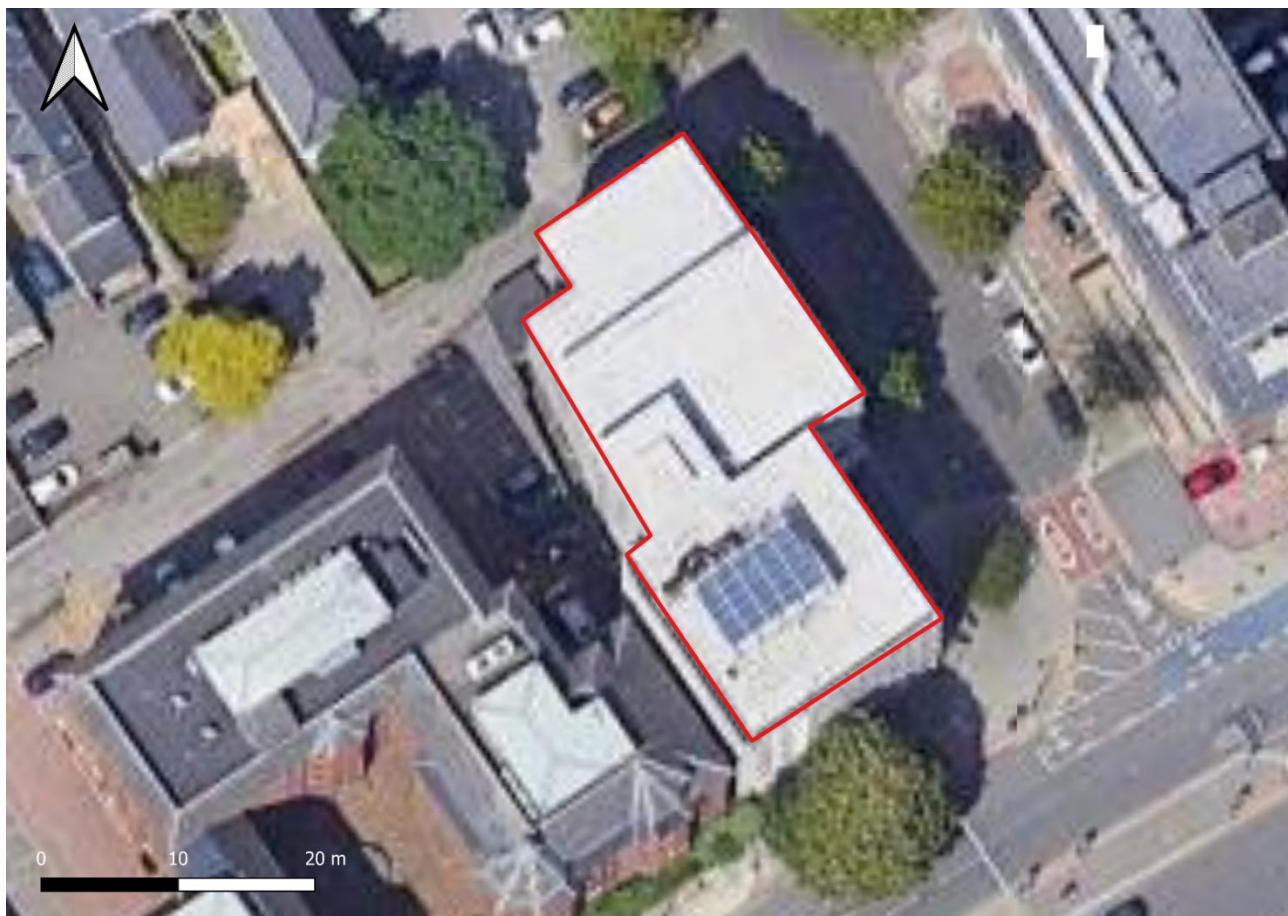
**Figure 1 - Structure locations and suitability.**

The roofs were flat comprised of bitumen felt. The roof of the structure at the top of the building had raised lead flashing creating a suitable roosting location for bats.

| Suitability for bats | Potential roost features and evidence of use identified |
|---|---|
| Low | <p>The following potential roosting feature was identified on the structure:</p> <p>Feature 1: raised lead flashing on the roof at the top of the structure.</p> <p>This feature is considered sub-optimal as is unlikely to offer thermal stability to roosting bats.</p> <p>The structure is considered to be of low suitability for roosting bats as the potential roosting feature identified is only considered suitable to be used by individual bats opportunistically. However, is not considered suitable to support bats on a regular basis or a roost of high conservation concern.</p> |

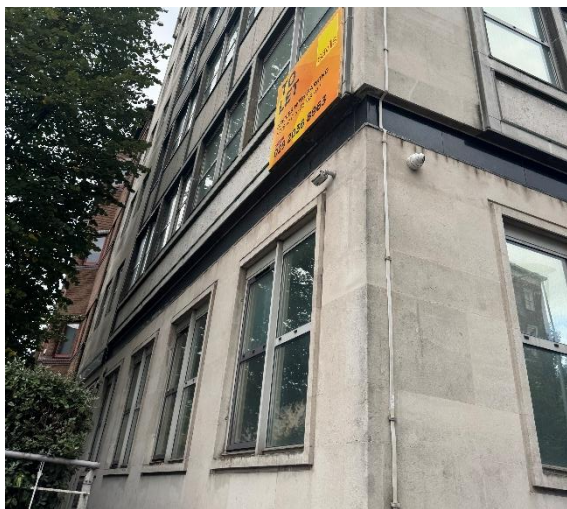
**Figure 2 – View of southern side.**

The structure is a multi-storey building formerly used as offices. The exterior is comprised of concrete panels. No cracks within concrete panels were identified and mortar was in good condition. There are numerous windows on each floor and elevation, these sit in metal frames, which are flush to the external walls. Netted scaffolding was present on the eastern side of the building during the survey, limiting access to and inspection of this section. The netting may also prevent and restrict bats from entering or leaving any roosting features, if present. That said, as noted in the constraints section, this area is of the same age and construction as the rest of the building, which offers negligible roosting suitability, so this limitation is not considered significant.
